PBY Catalina

Walk Around

By William Scarborough

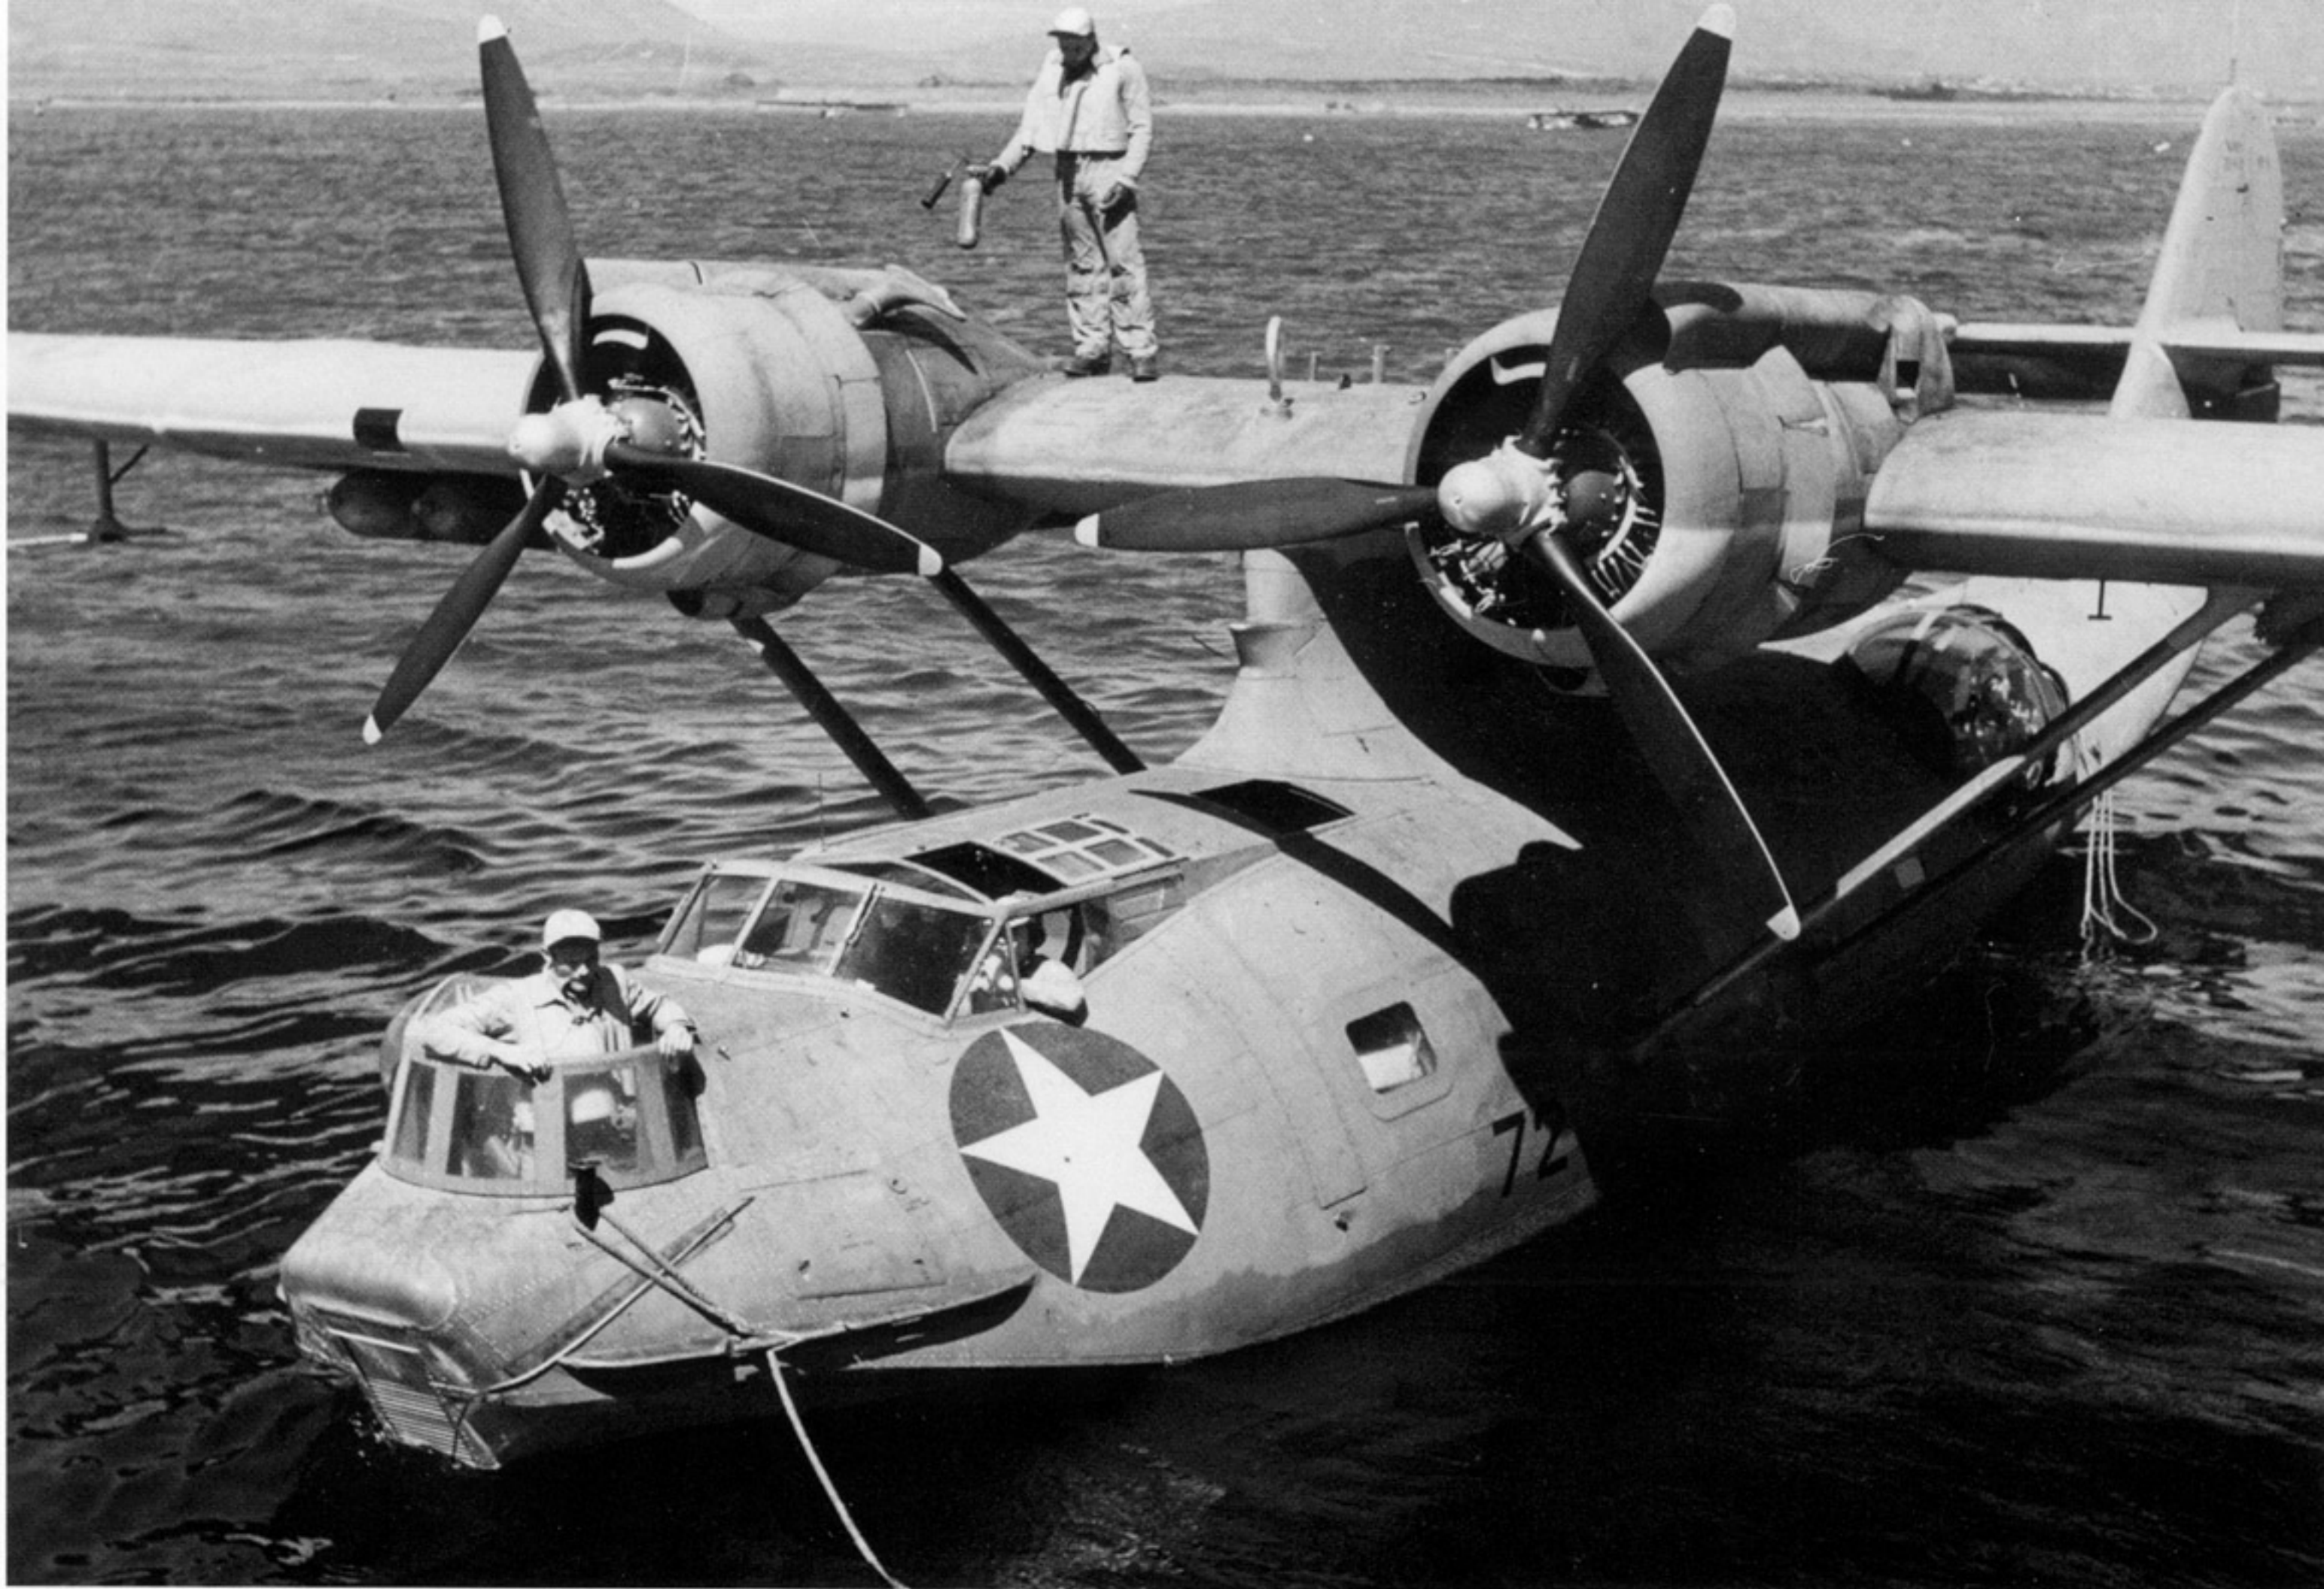
A crewman stands by with a fire extinguisher as the pilot prepares to start engines of this PBY-5, No. 72, in July of 1943, in the Aleutian Islands. Once started, the aircraft will be taxied to its assigned buoy in the seaplane anchorage. The crewman in the bow turret is standing by to release the mooring line from the snubbing post when signaled by the pilot. Lines hanging from the port blister are attached to a sea anchor used to control speed during approach to the ship. This Catalina is equipped with flame damper exhaust stacks and a thermal wing deicing system. (USN/National Archives via Dave Lucabaugh)

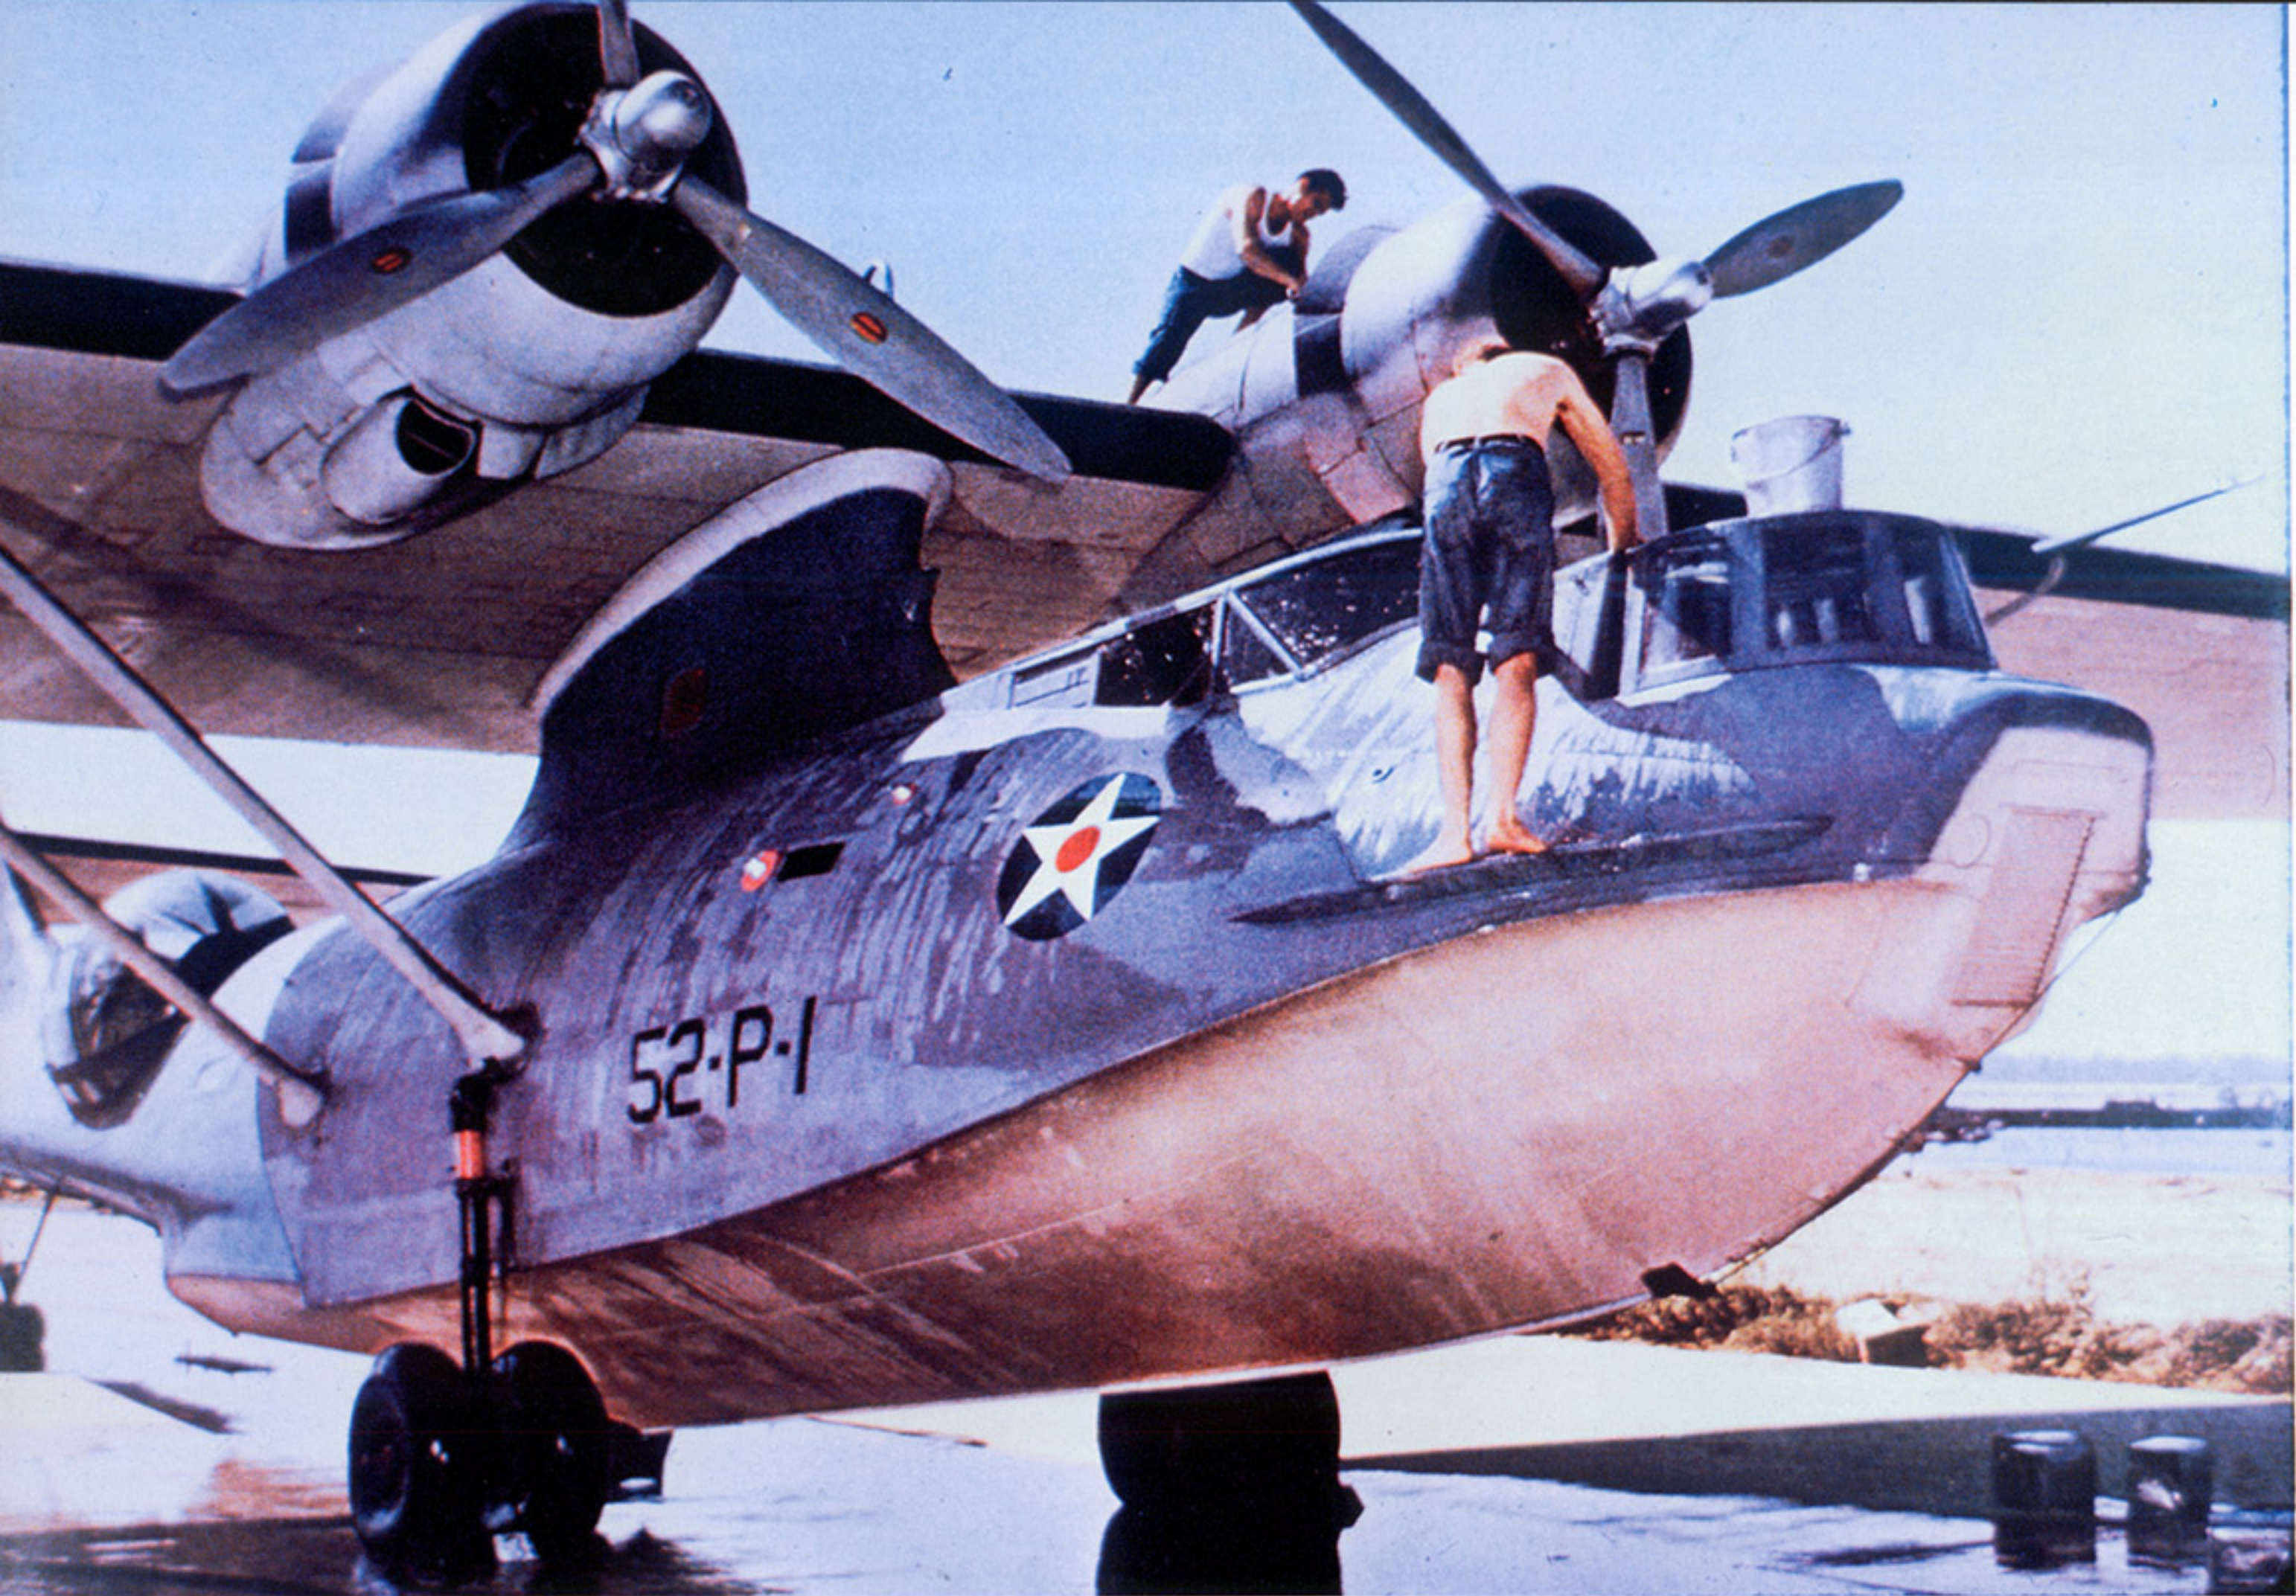
Crewmen wash down a PB4Y-2 of VP-52 (52-P-1) with fresh water after a mission. Removal of salt water helped cut down on corrosion and prolonged the life of the airframe. This aircraft carries the early style U.S. national markings in use prior to 1942 with the Red center dot. The wing support pylon on the fuselage center also housed the flight engineers station and there was a window on each side of the pylon. (National Archives via Mark Aldrich)

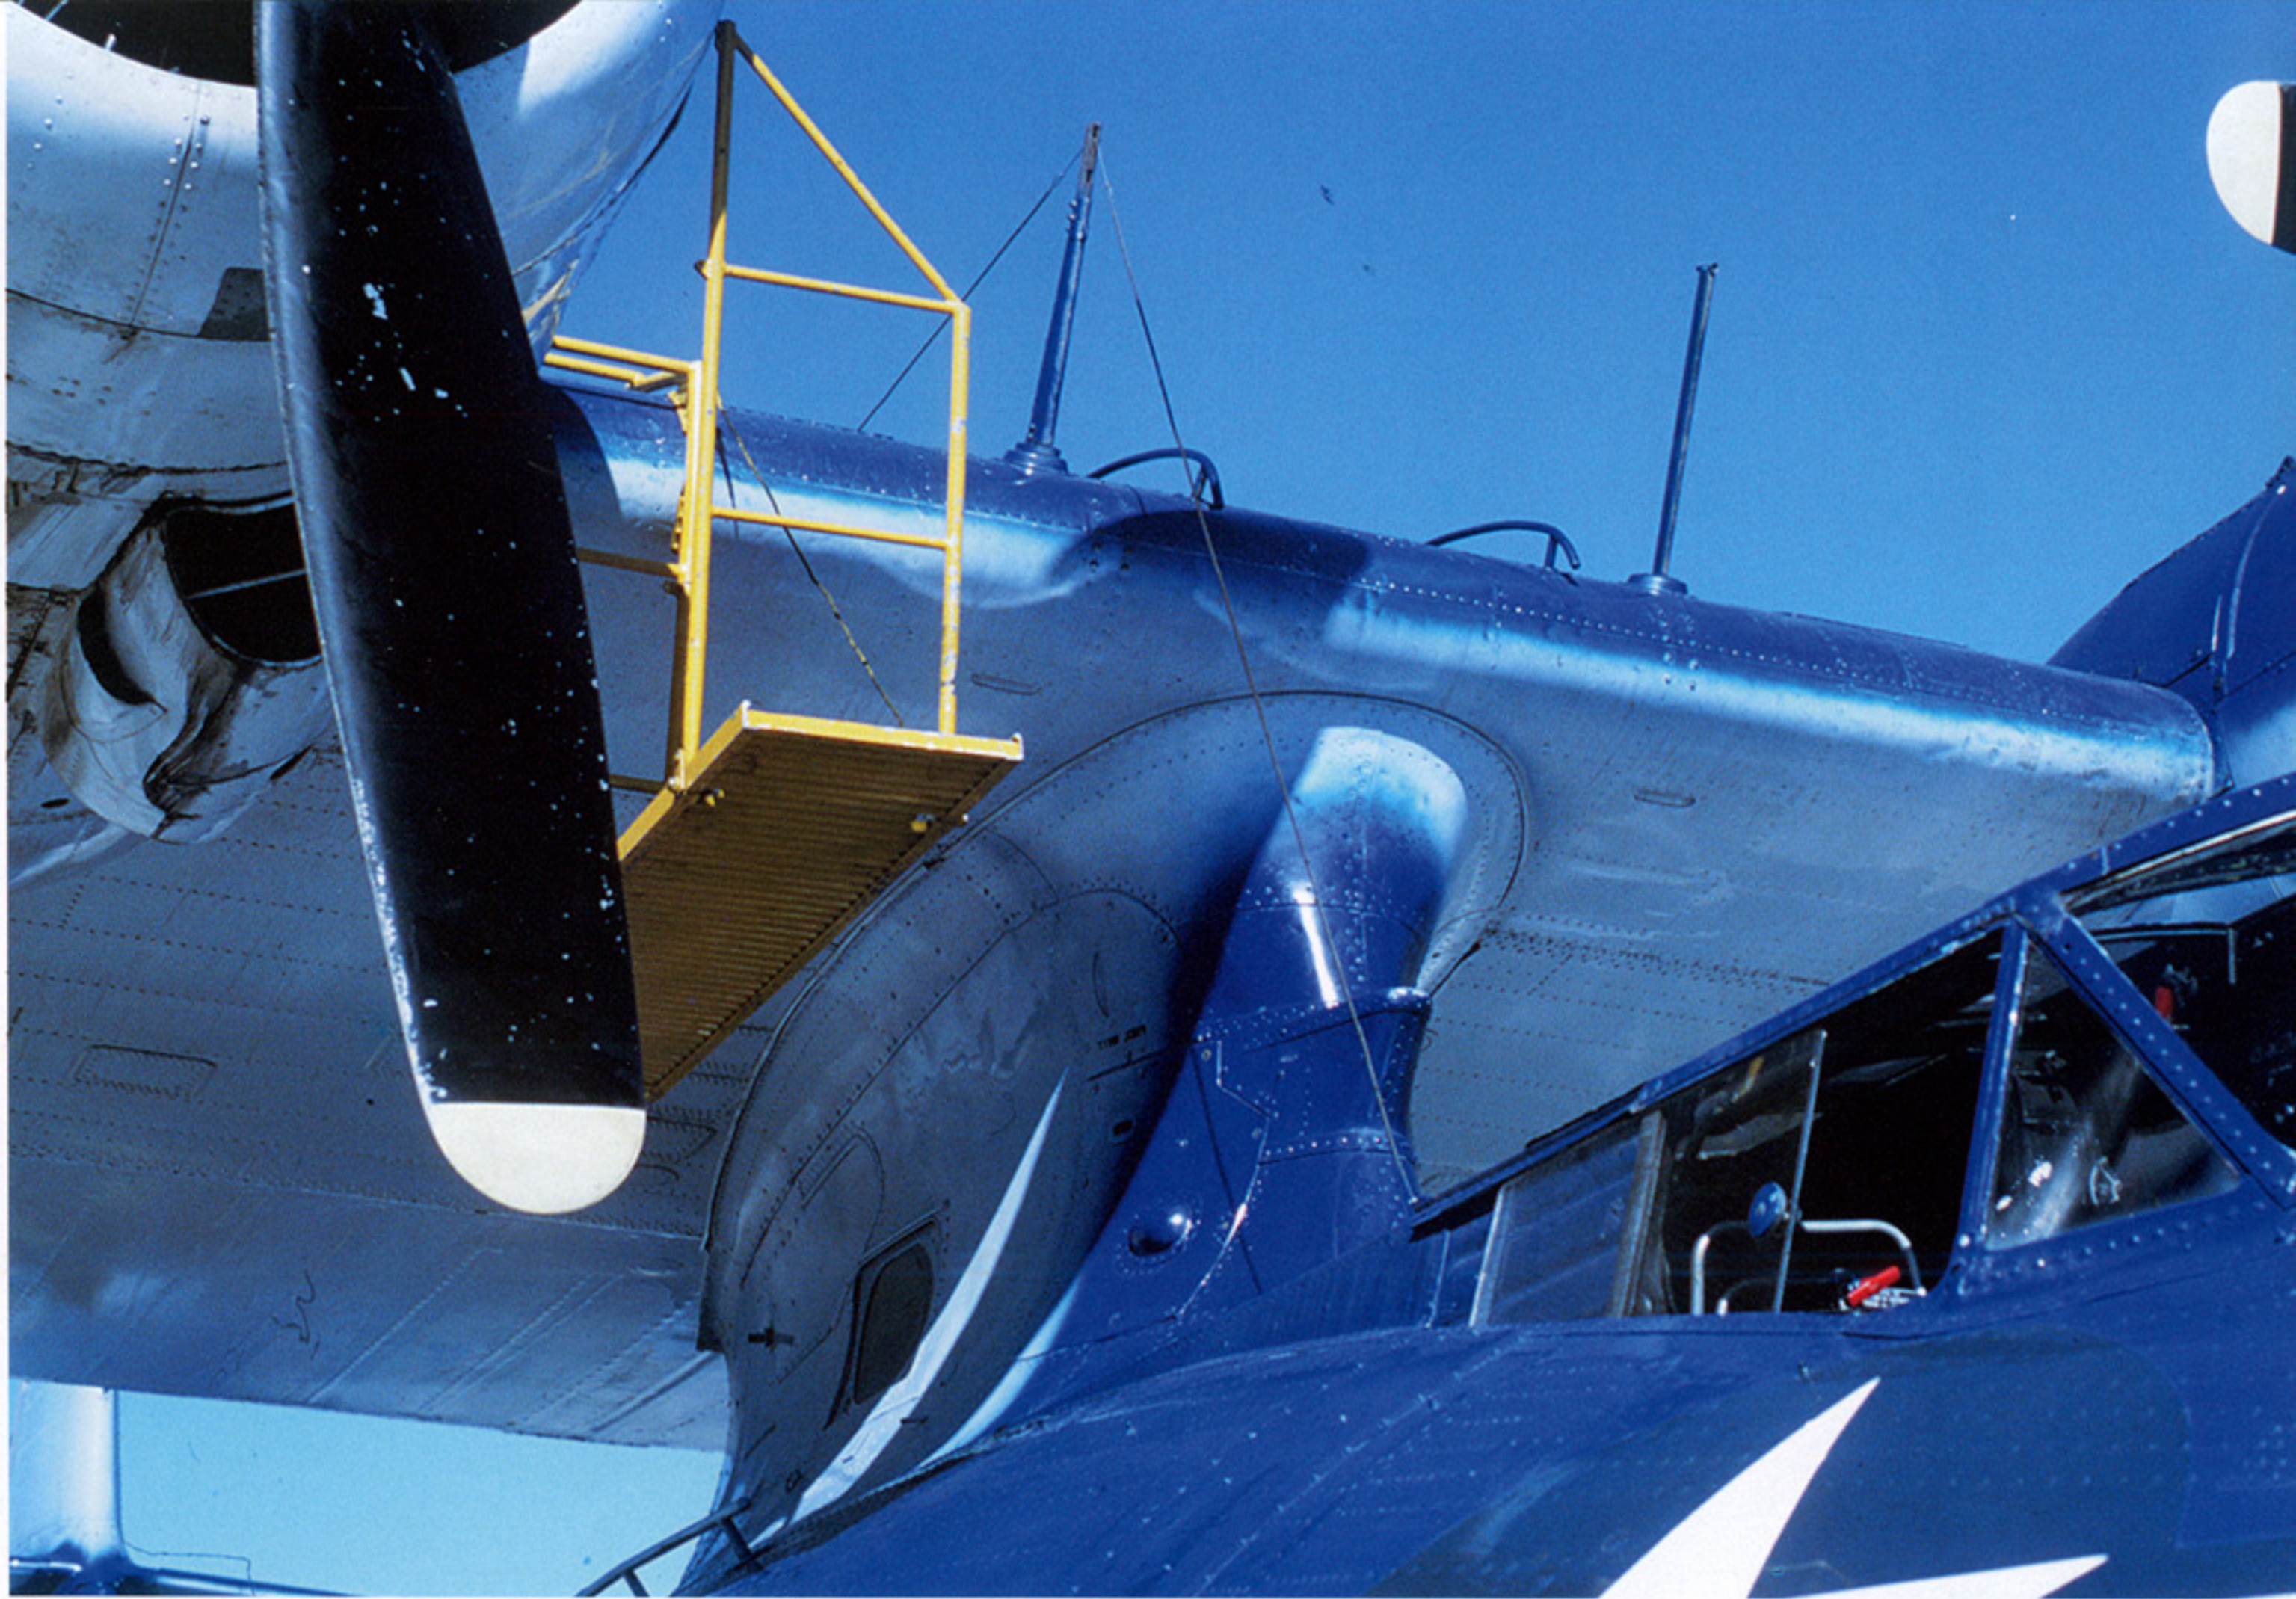
The wing center support pylon was the main support for the massive 104 foot wing. The pylon housed the flight engineer's station with his control panels and equipment. There was a window on each side of the pylon. The ledge half way up the front of the pylon was the pylon step used by personnel to gain access to the top of the wing from the fuselage. This PBY has two non-standard antenna masts on the upper wing along with a pair of non-standard hand holds, probably added by the CAF. (Mark Aldrich)

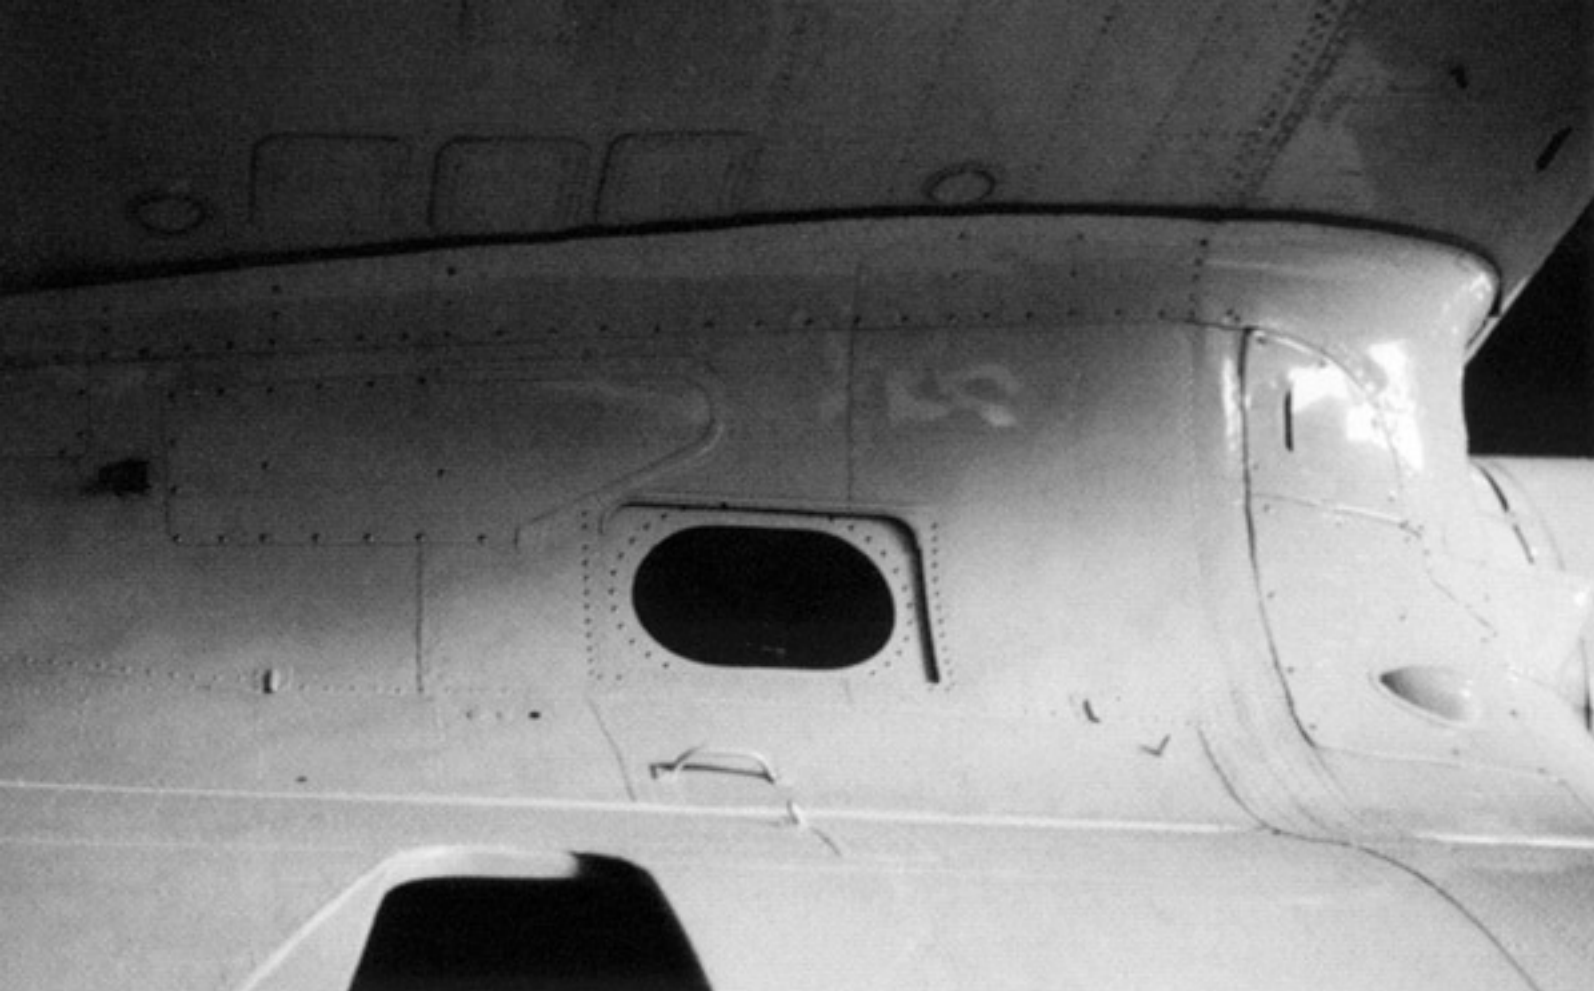
The wing center support pylon of a PBY-5A. The small window allowed the flight engineer some view outside the aircraft, to visually check each engine. There was an identical window on the other side of the pylon. There is a small non-standard hand hold below the window. (Mark Aldrich).

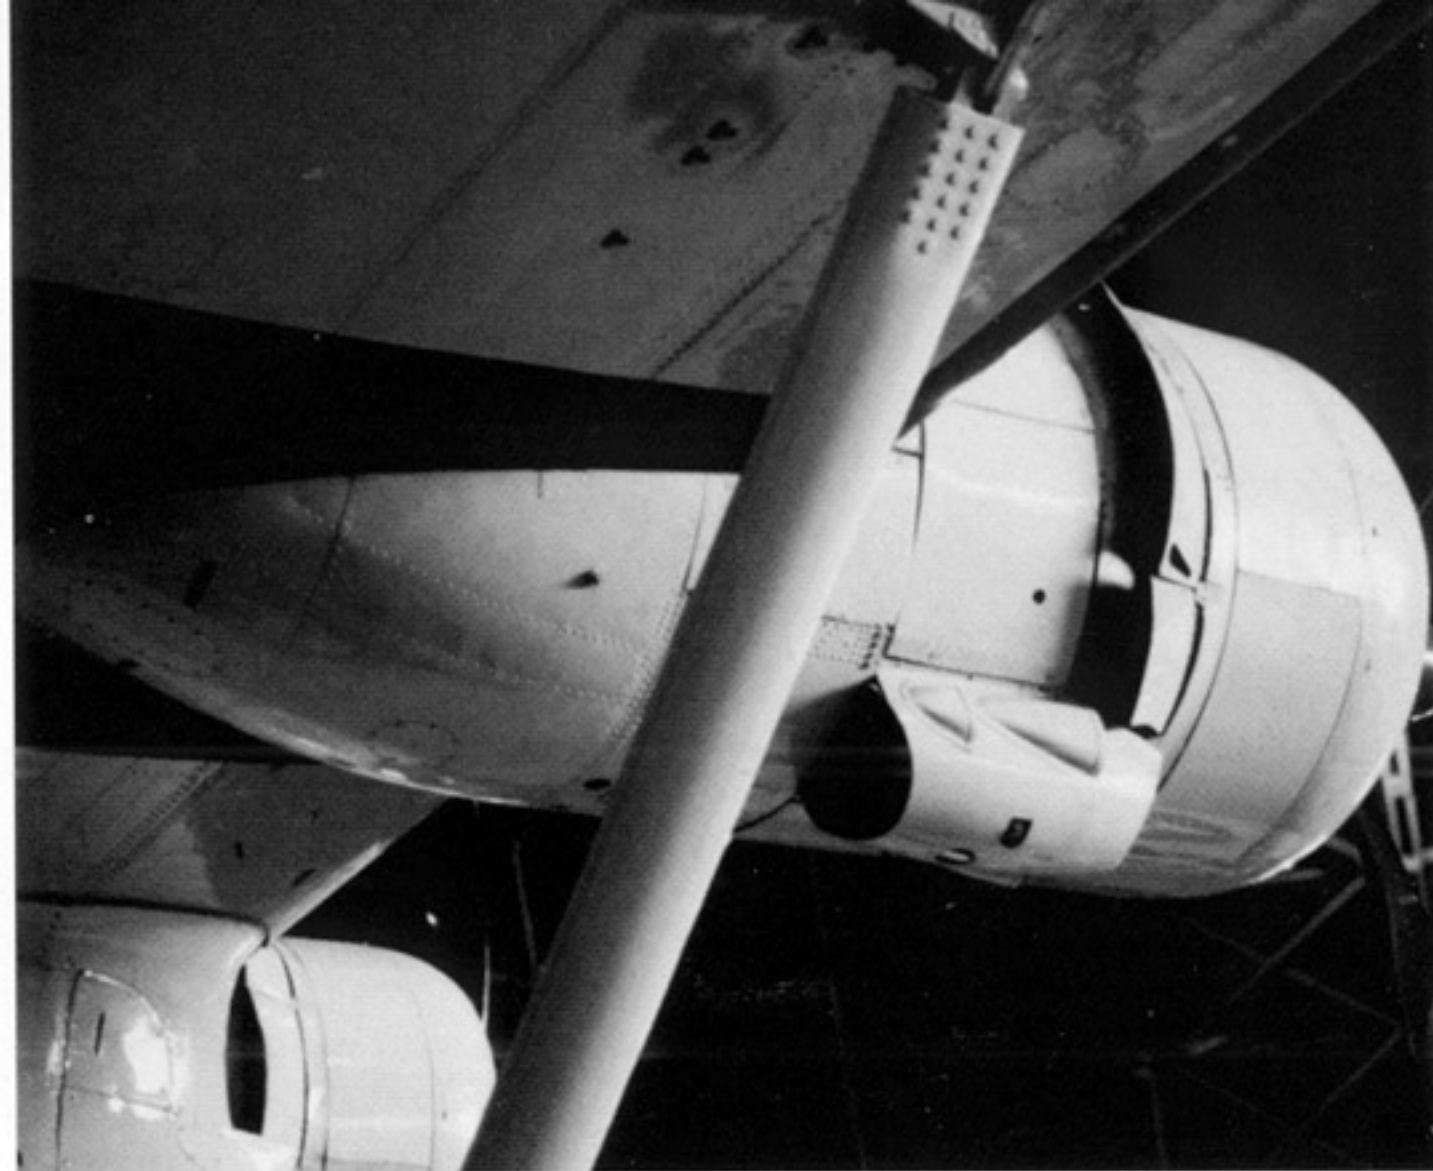
Aircraft in service had the strut attachment bolt points covered by a fairing to cut down on drag. (Mark Aldrich)

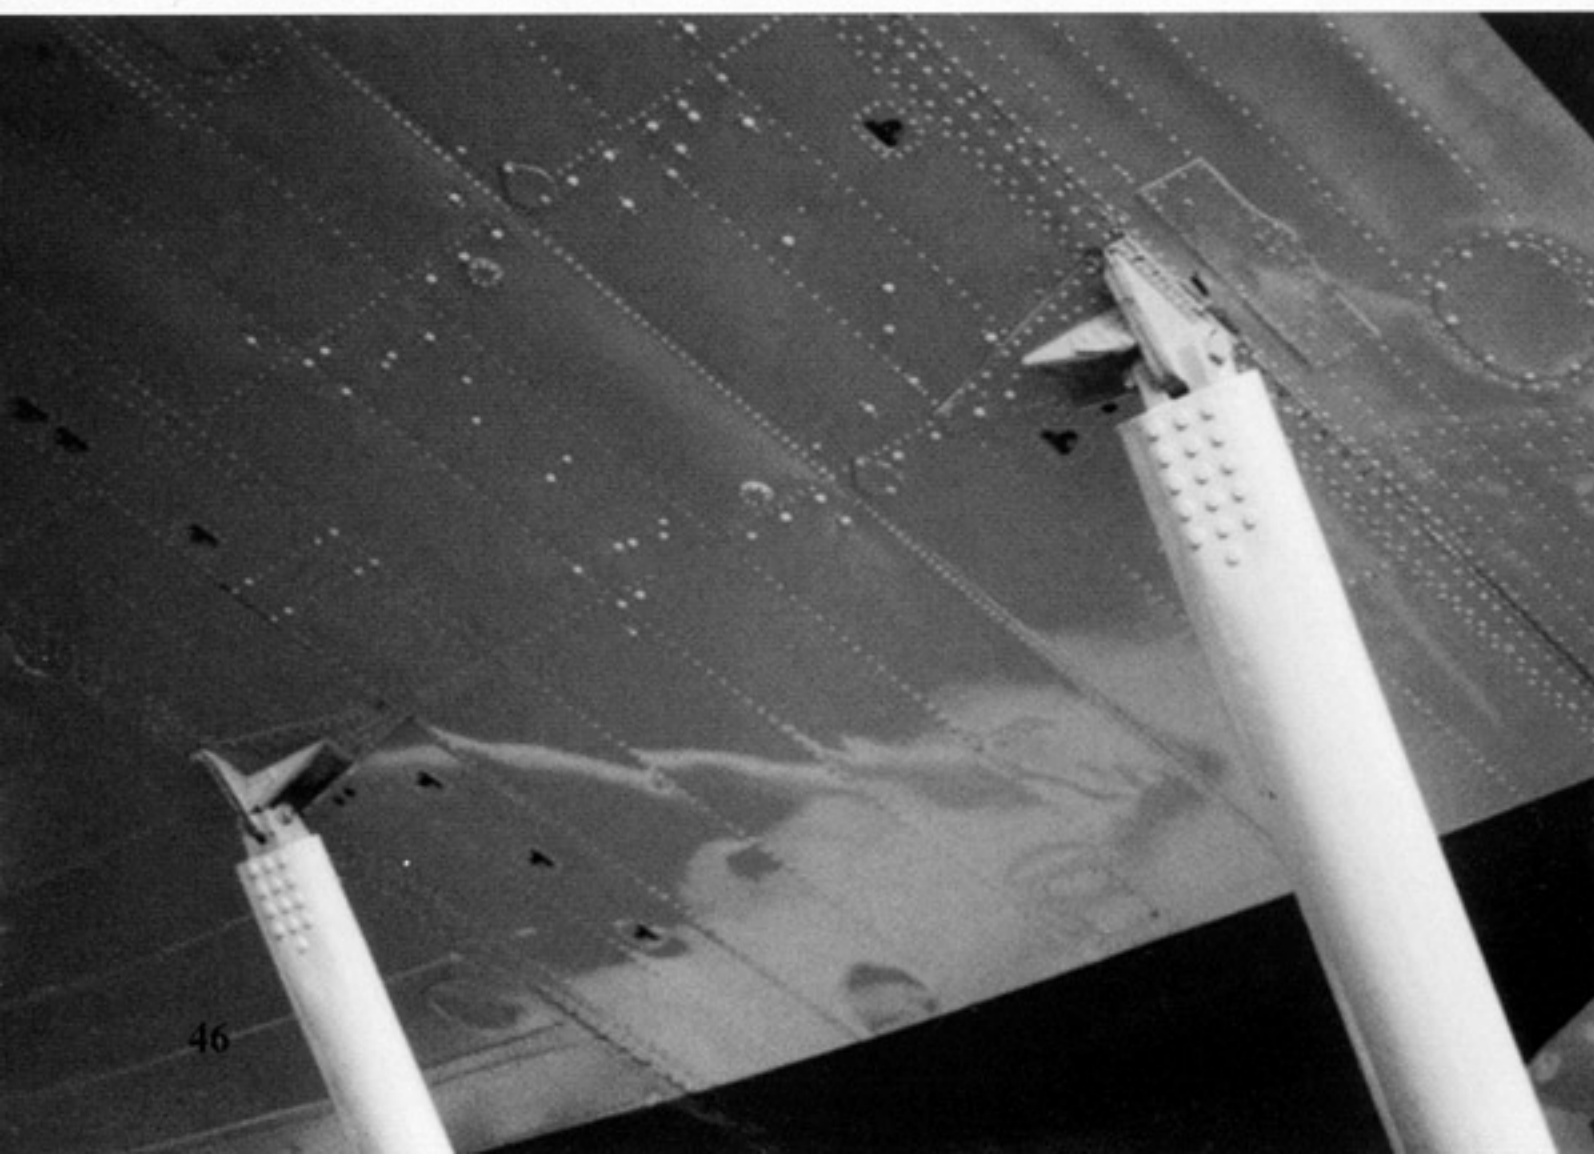
The fuselage strut attachment points were on either side of the main landing gear wheel wells on the PBY-5A and later variants. These struts were each attached to a main fuselage structural frame on all PBY variants. (Mark Aldrich)

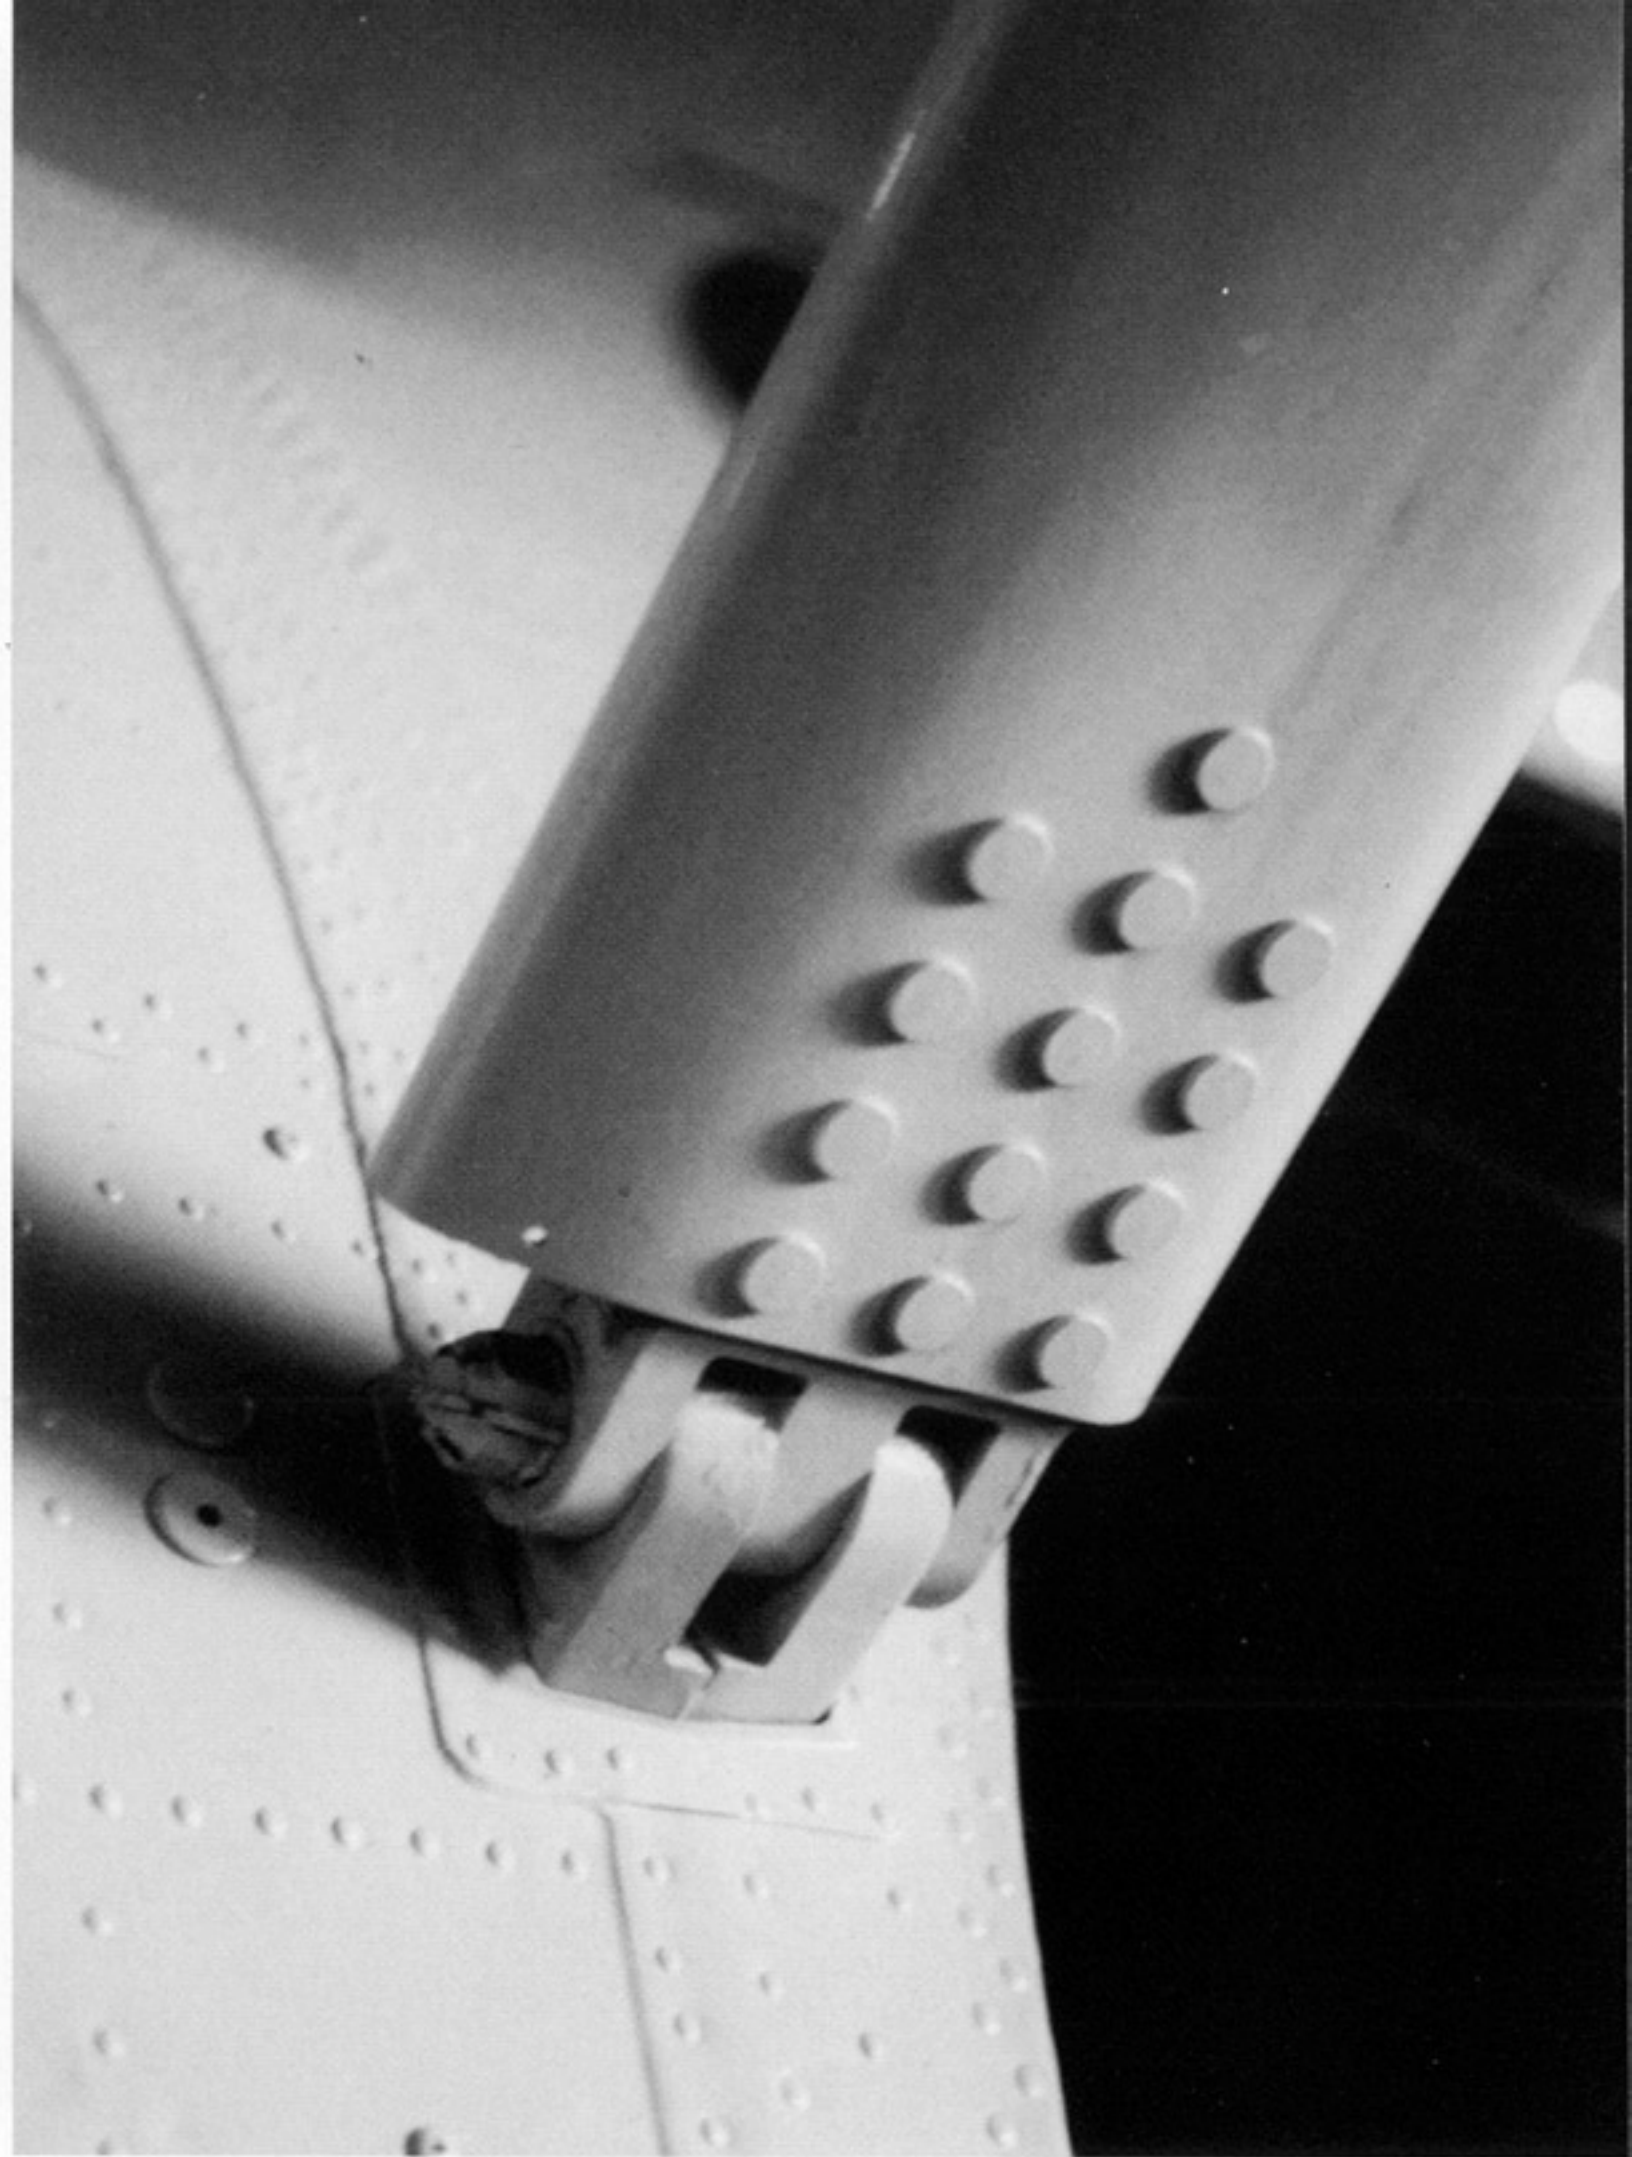
Along with the wing center pylon, the four wing struts were the main structural members that support the 104 foot wing. In flight in rough air, the wing tips of the PBX often flexed upward and downward. The attachment points were mounted on two of the main fuselage frames located on either side of the main landing gear wheel well of the PBX-5A. The forward frame formed the aft bulkhead for the radio/navigation compartment and the rear frame formed the forward bulkhead of the bunk compartment. (Mark Aldrich)
